SPR – SPN SERIES

SERVICE ANALYSIS

REPLACEMENT OF THE AUGER, WATER SEAL AND BEARINGS

SPR 80-120-200

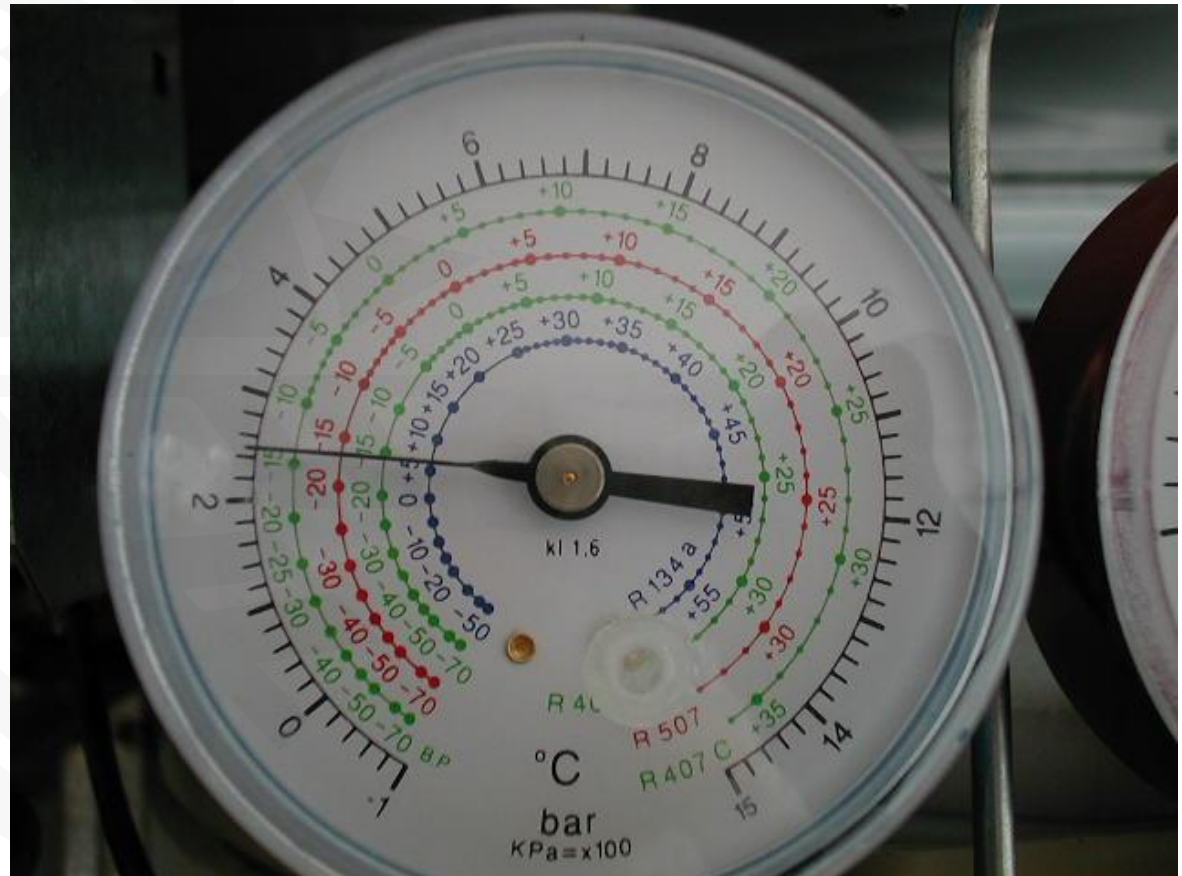
- Refrigerant charge. High
side pressure must be
between 17÷18 bar
(240÷250 PSI)..... (R404A)

.....while suction
pressure must be 2.5
bar (35 PSI) (R404A)

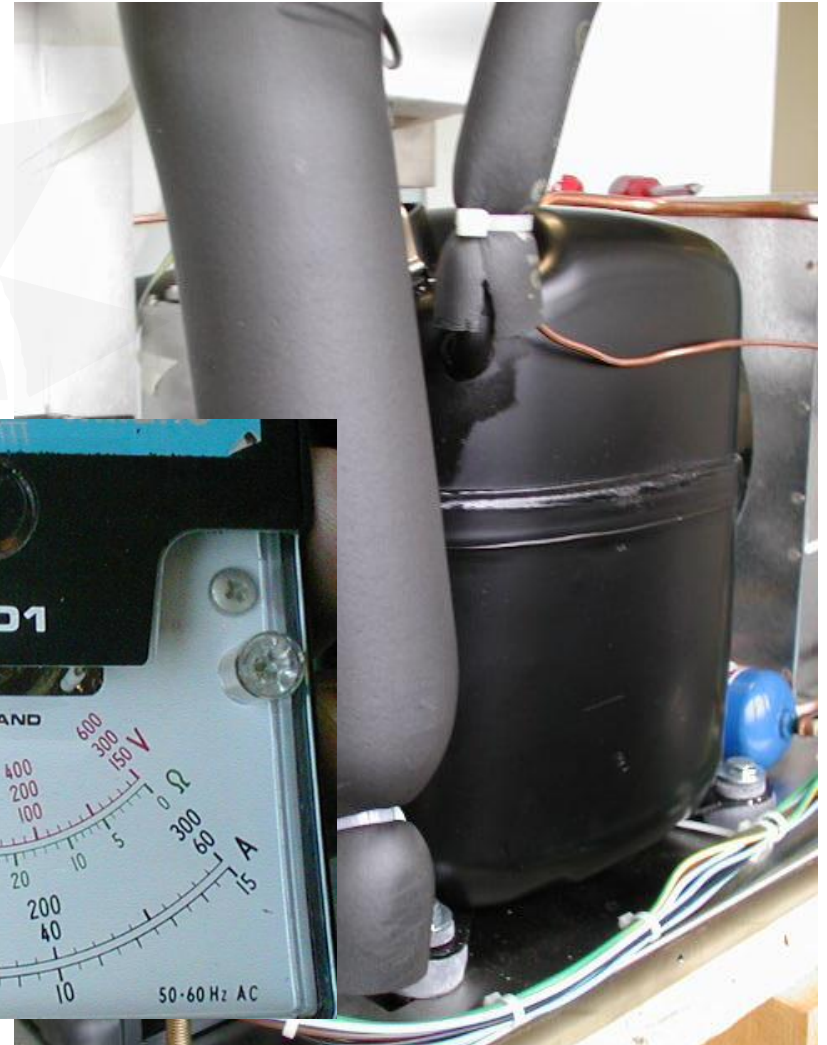
- Refrigerant charge
- Operation of Compressor

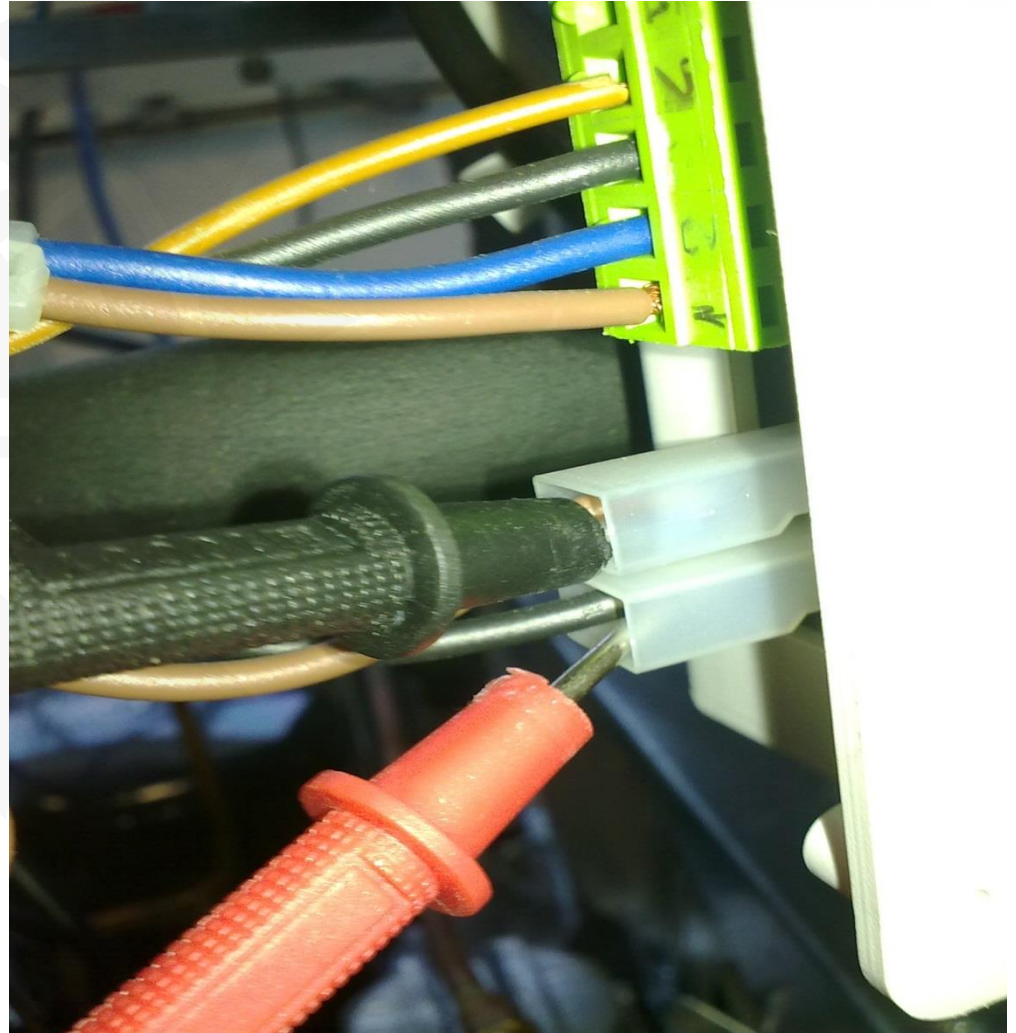
- Refrigerant charge
- Operation of Compressor
- Power out on spade connectors of the PC Board

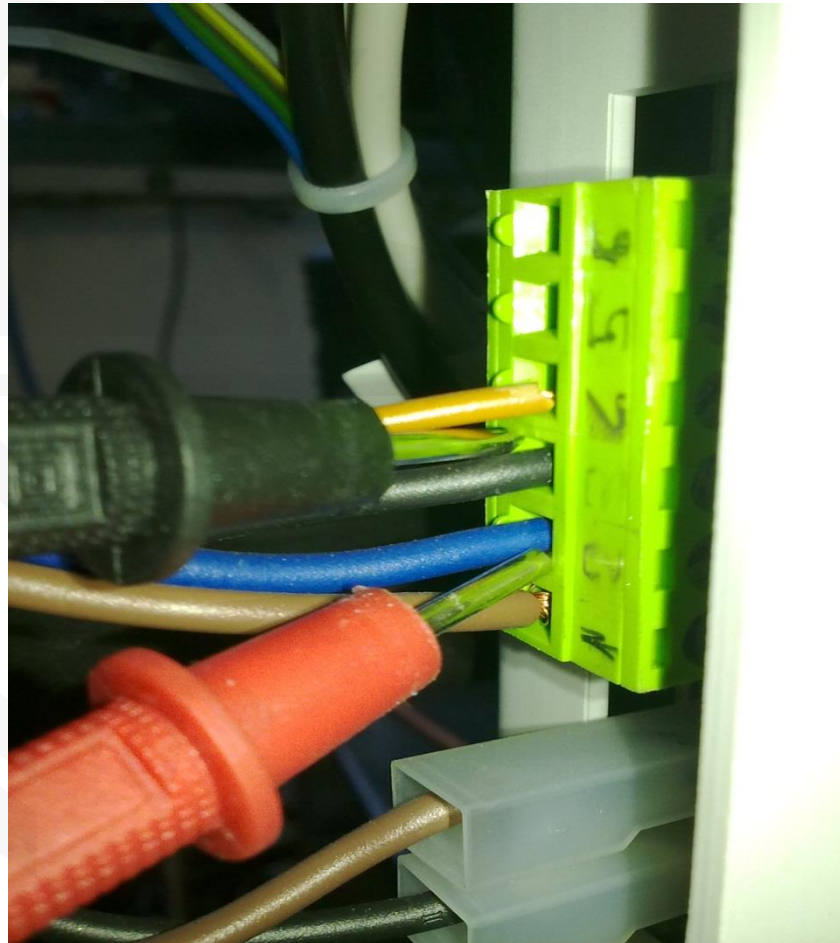
- Power out on the
contacts 2 and 3 of
the PC Board

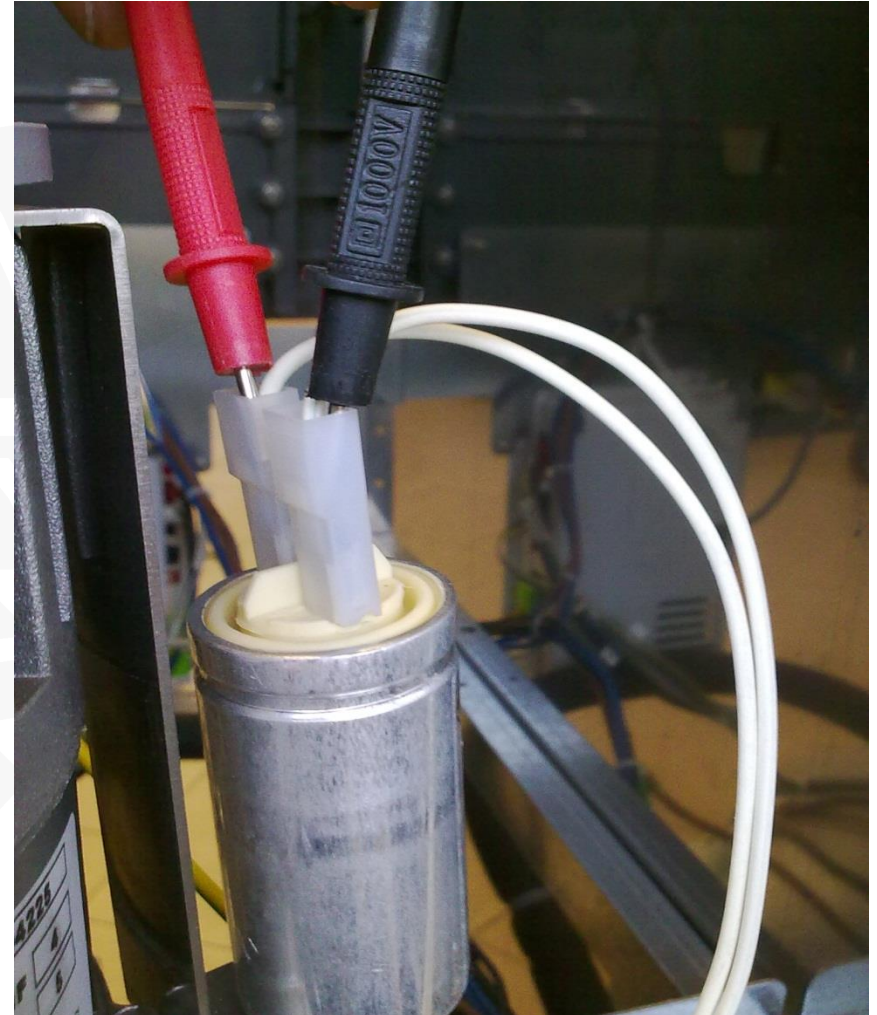
- Power out on the
contacts 2 and 3 of
the PC Board
- Drive motor with
open winding

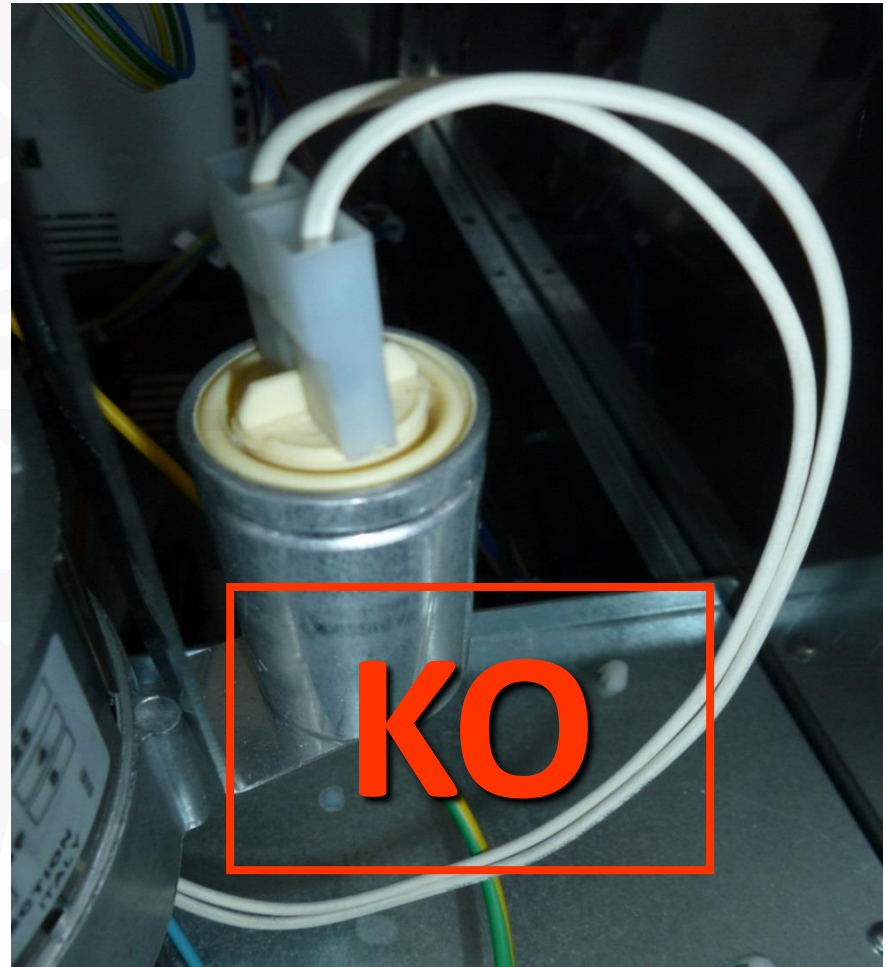
- Power out on the contacts 2 and 3 of the PC Board
- Drive motor with open winding
- Drive motor capacitor worn-out

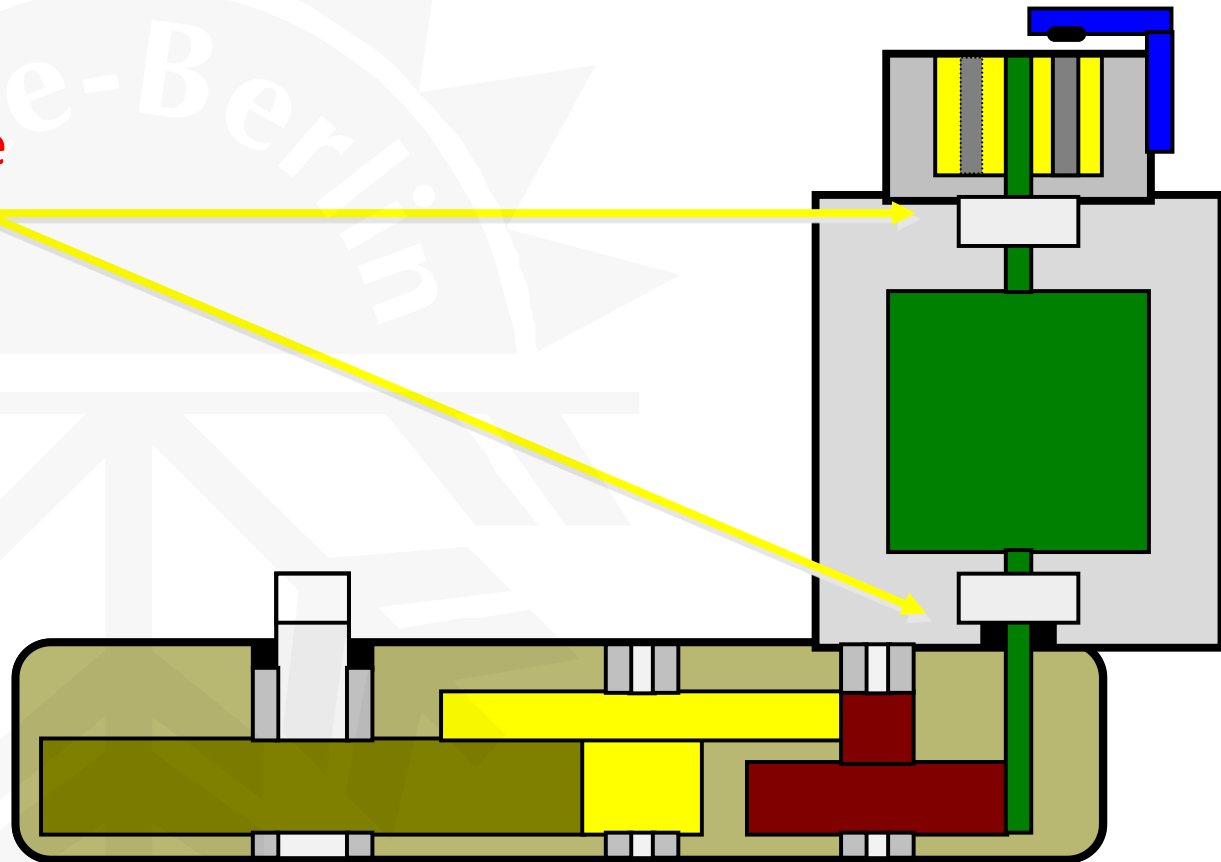
- Worn out drive motor bearings

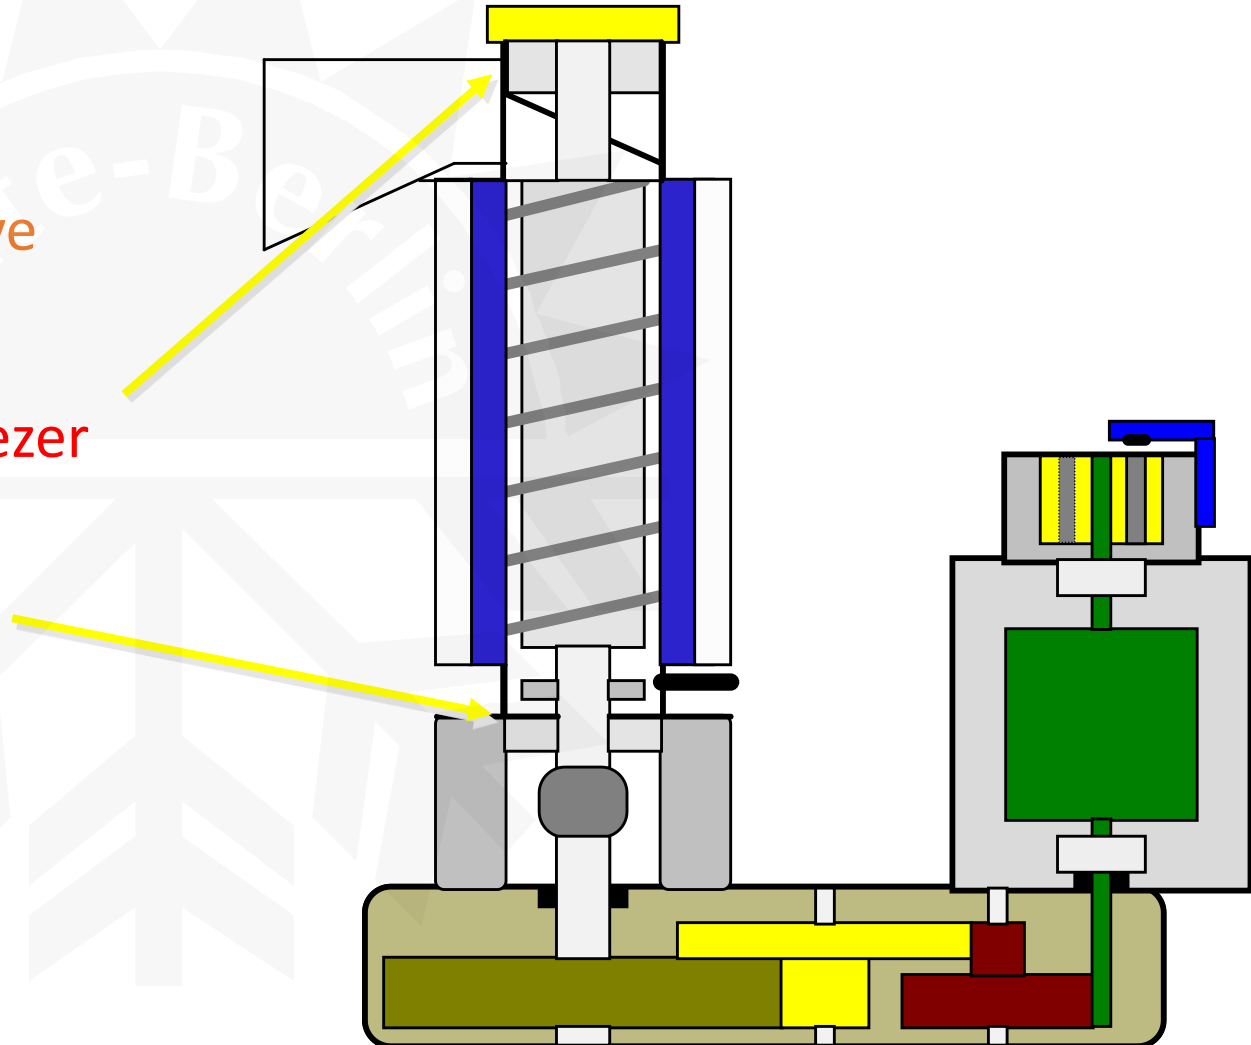
- Worn out drive motor bearings
- Worn out freezer top or bottom bearings

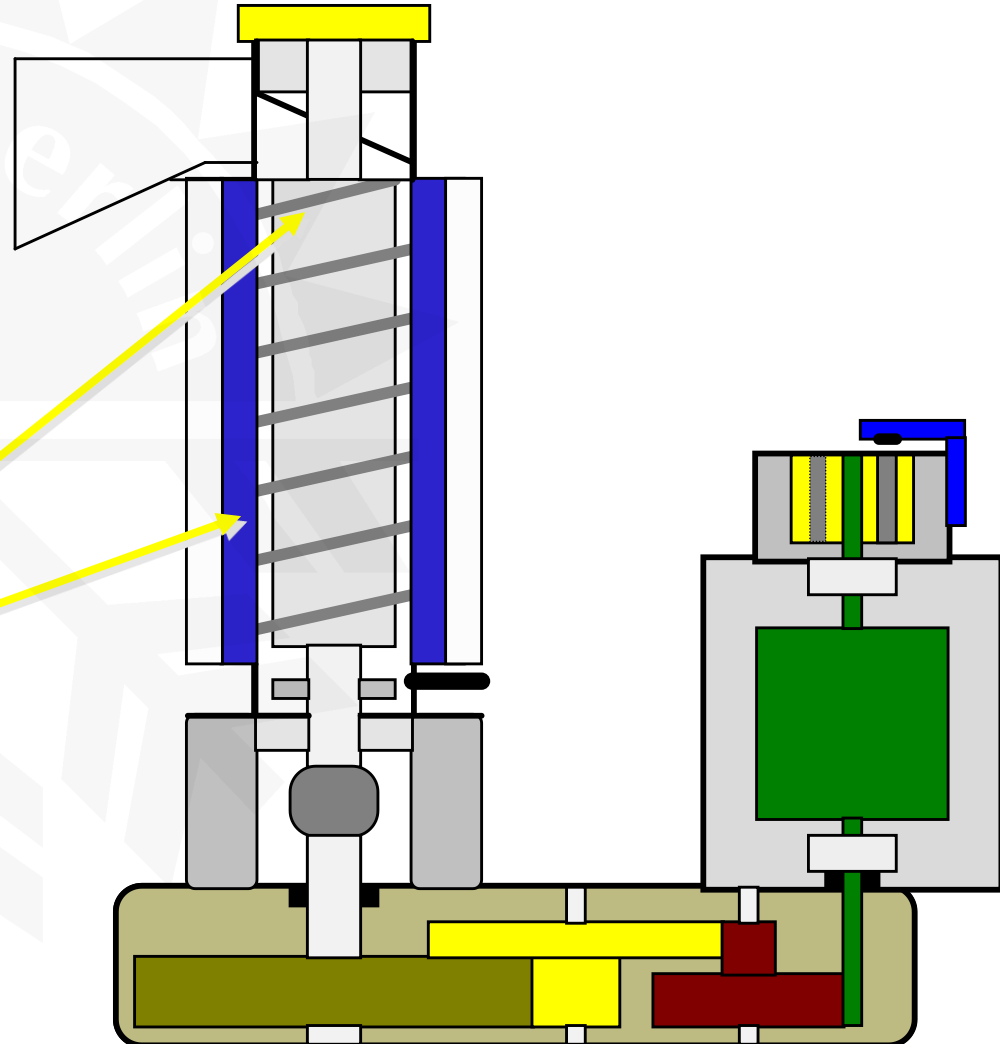
- Worn out drive motor bearings
- Worn out freezer top or bottom bearings
- Worn out auger/freezer

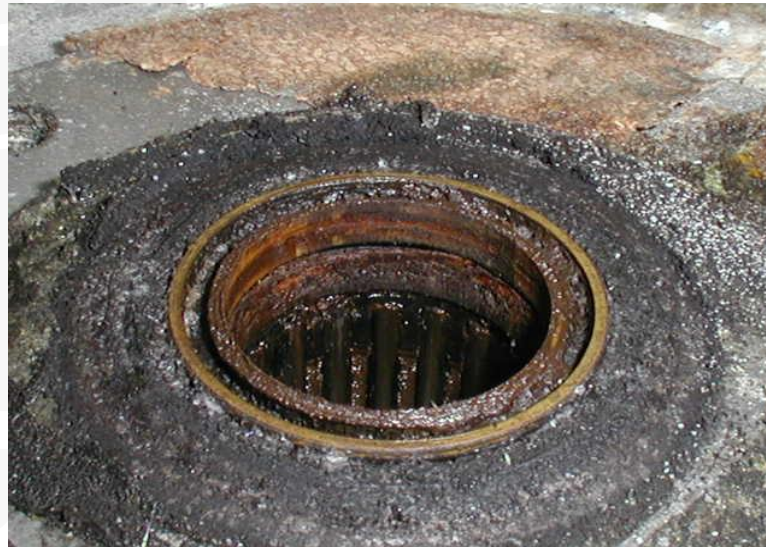
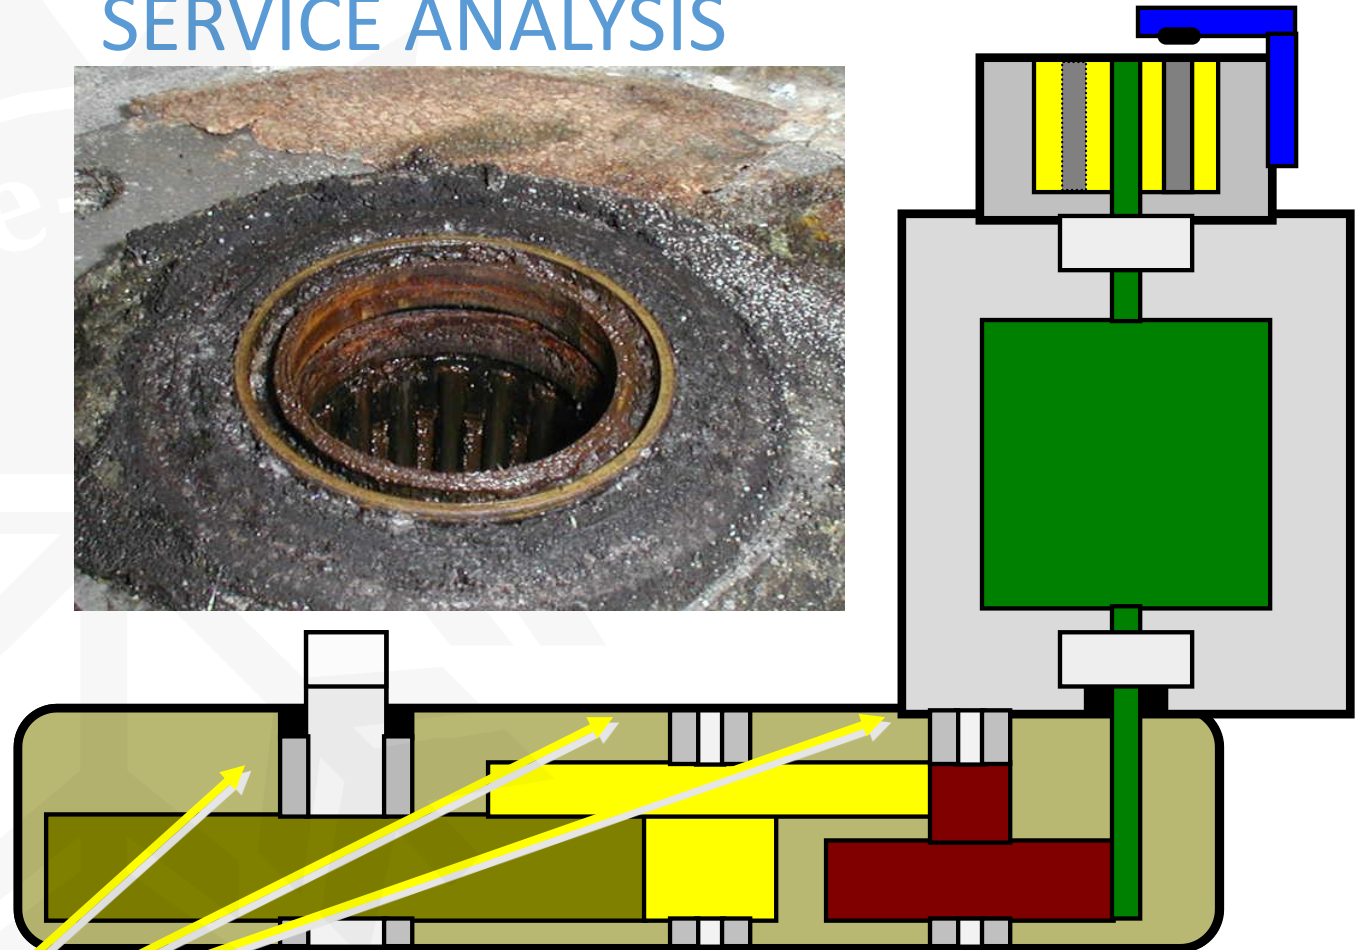
- Worn out drive motor bearings
- Worn out freezer top or bottom bearings
- Worn out auger/freezer
- Worn out gear box bearing/gears

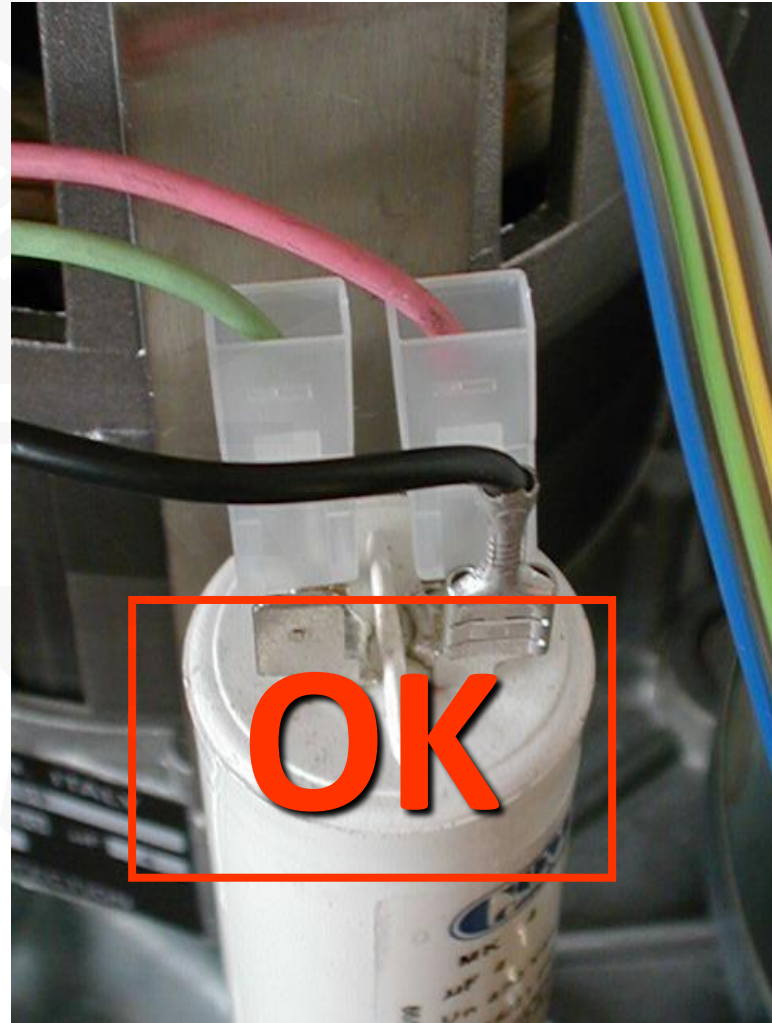
- Correct wires connection to the drive motor capacitor (ONLY ON THE OLD VERSION)

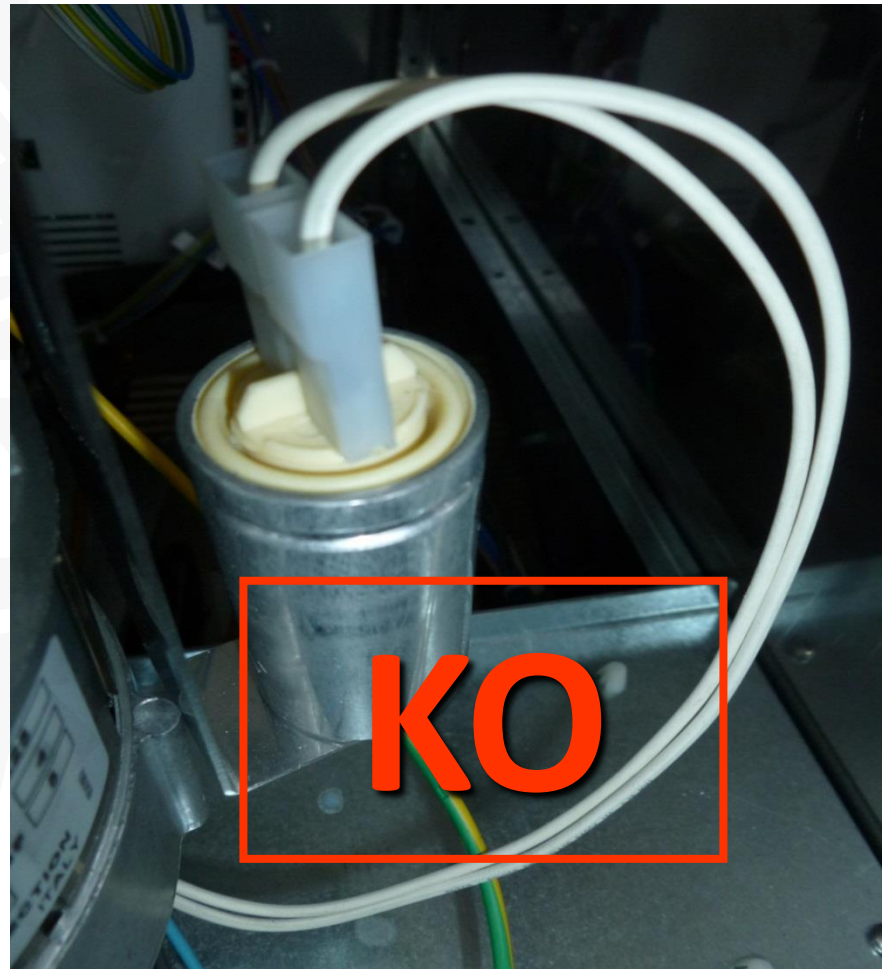
- Correct wires connection to the drive motor capacitor
- Drive motor capacitor worn-out

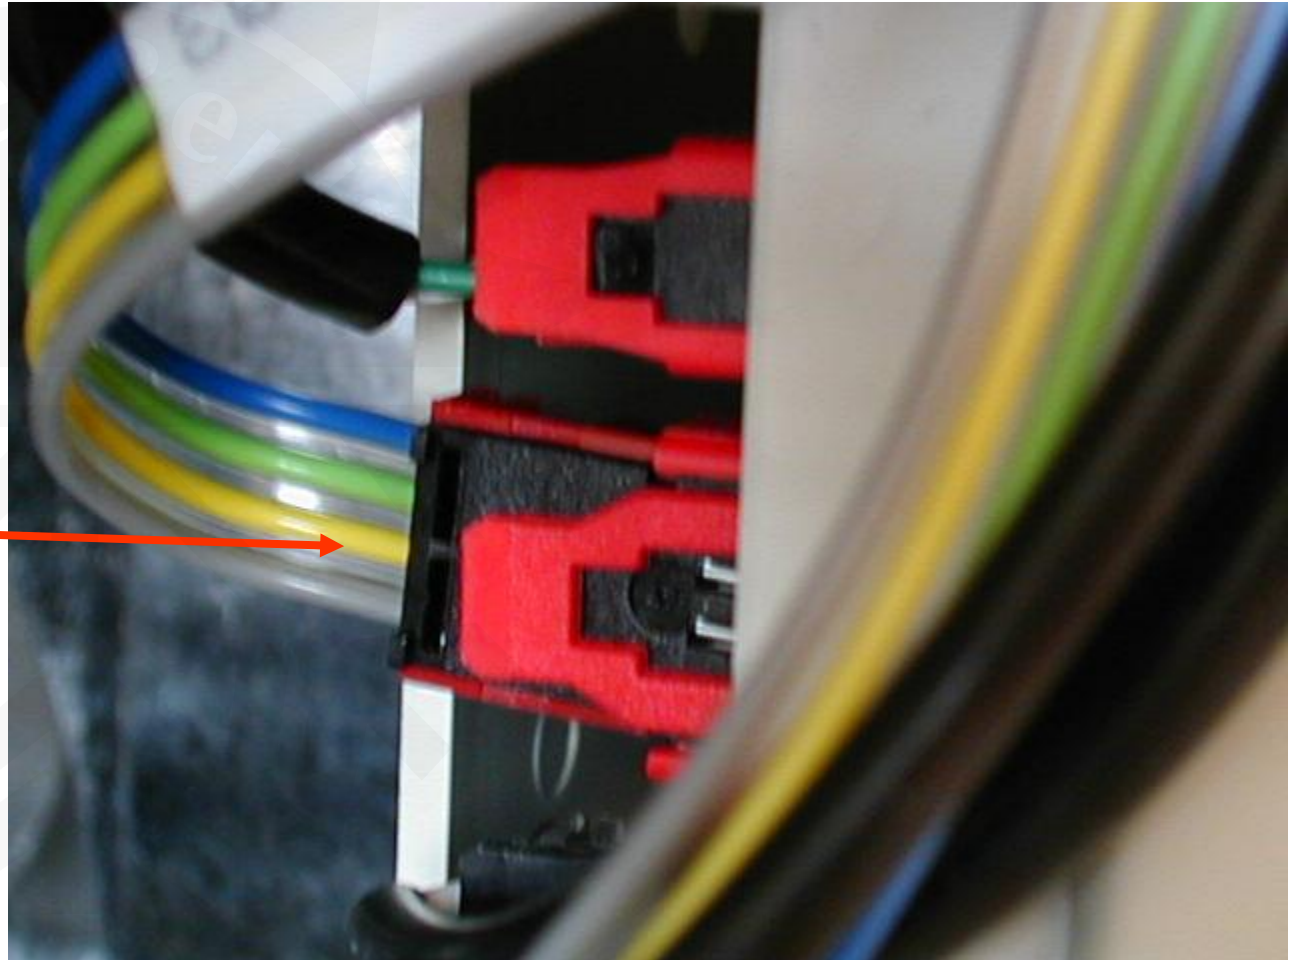
- Magnetic sensor unplugged

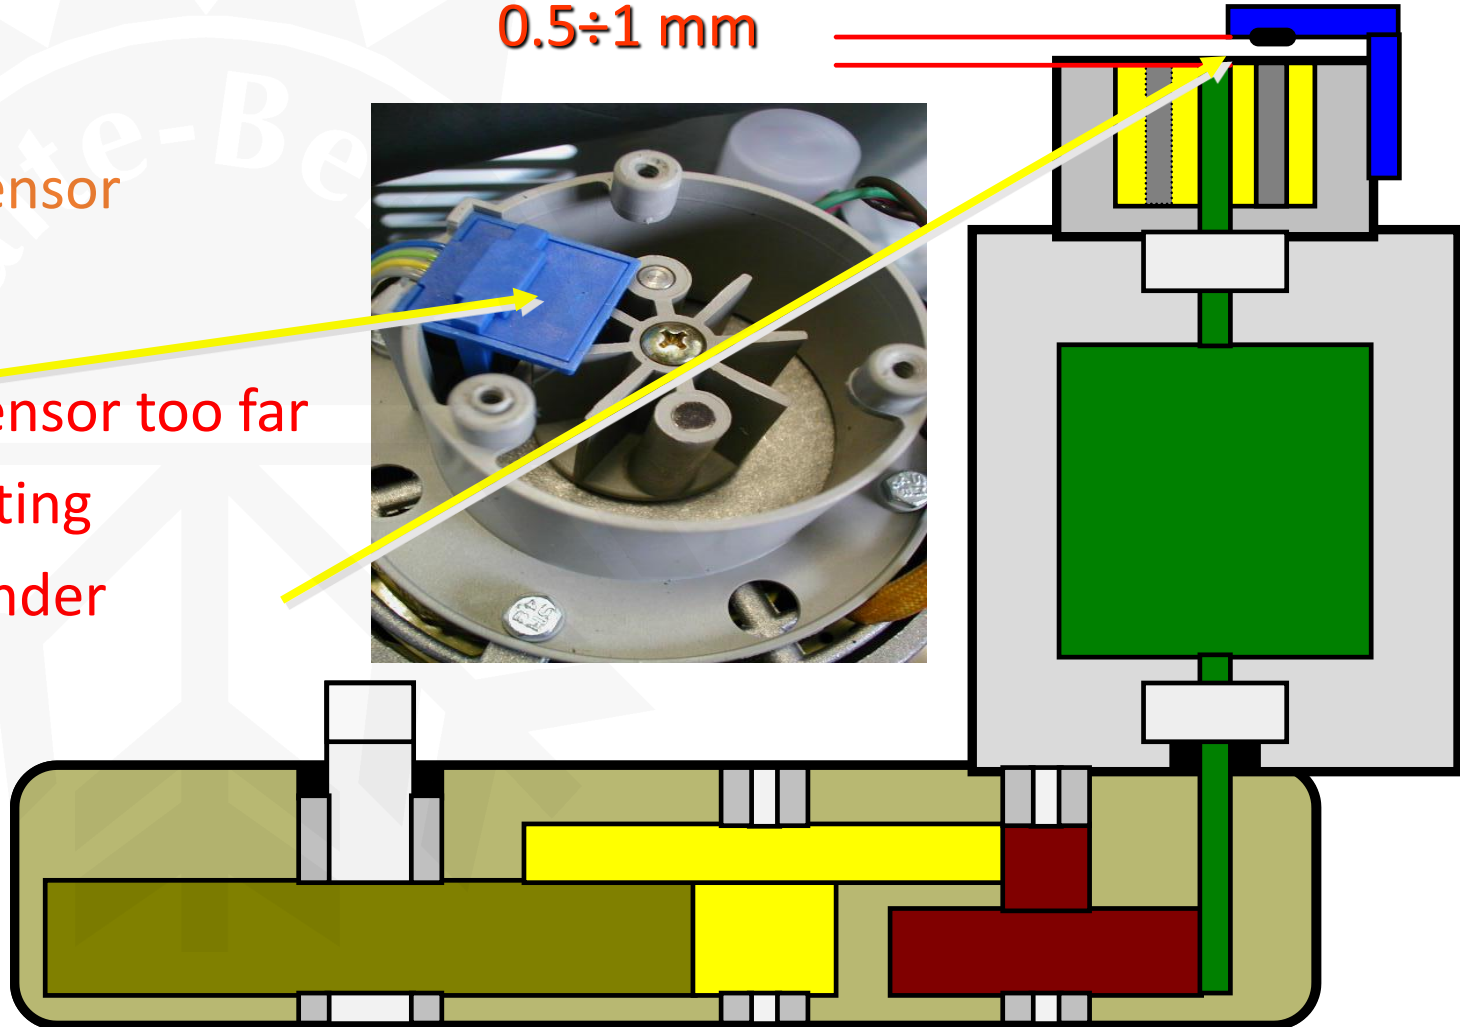
0.5÷1 mm

- Magnetic sensor unplugged
- Magnetic sensor too far from the rotating magnetic cylinder

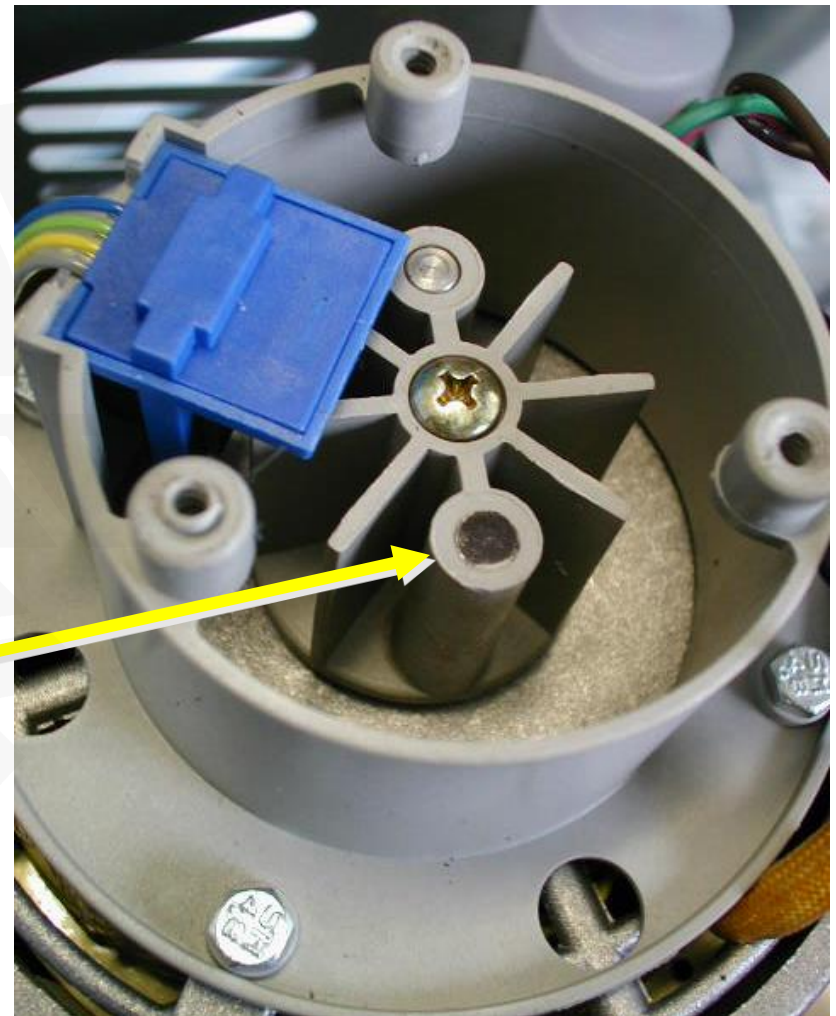
- Magnetic sensor unplugged
- Magnetic sensor too far from the rotating magnetic cylinder
- Magnetic cylinder partially or fully demagnetized

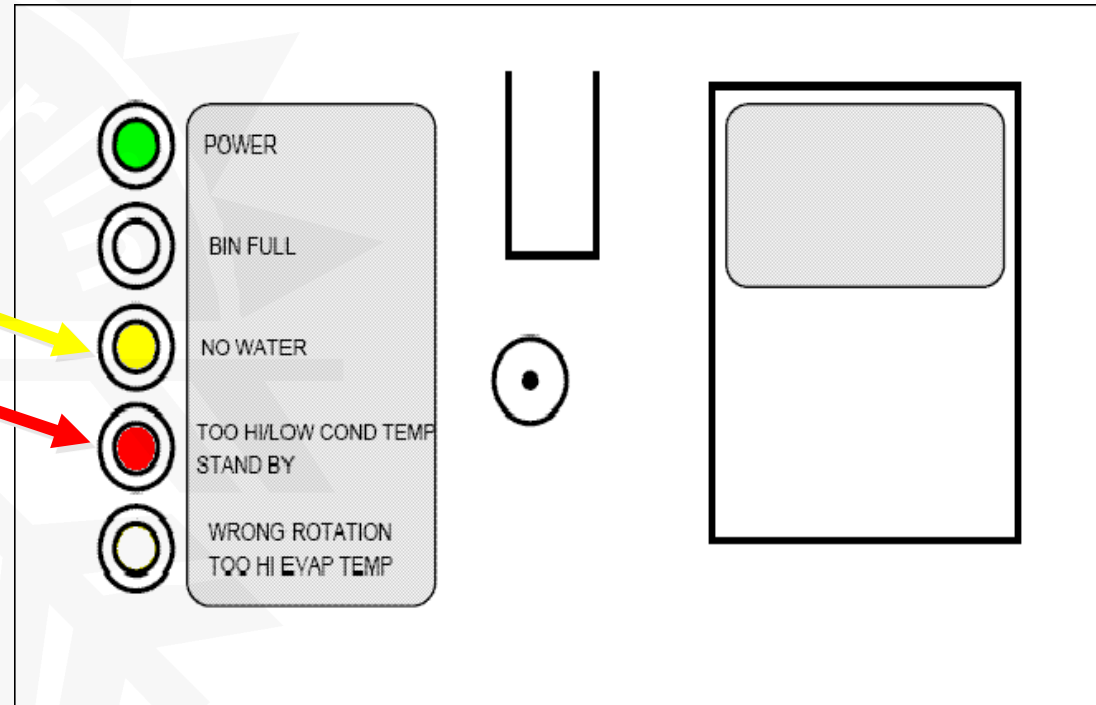
**CONDENSER SENSOR OUT
OF ORDER**

No Water YELLOW LED
+
Stand-by Red LED

BOTH ON STEADY

**REPLACE CONDENSER
SENSOR**

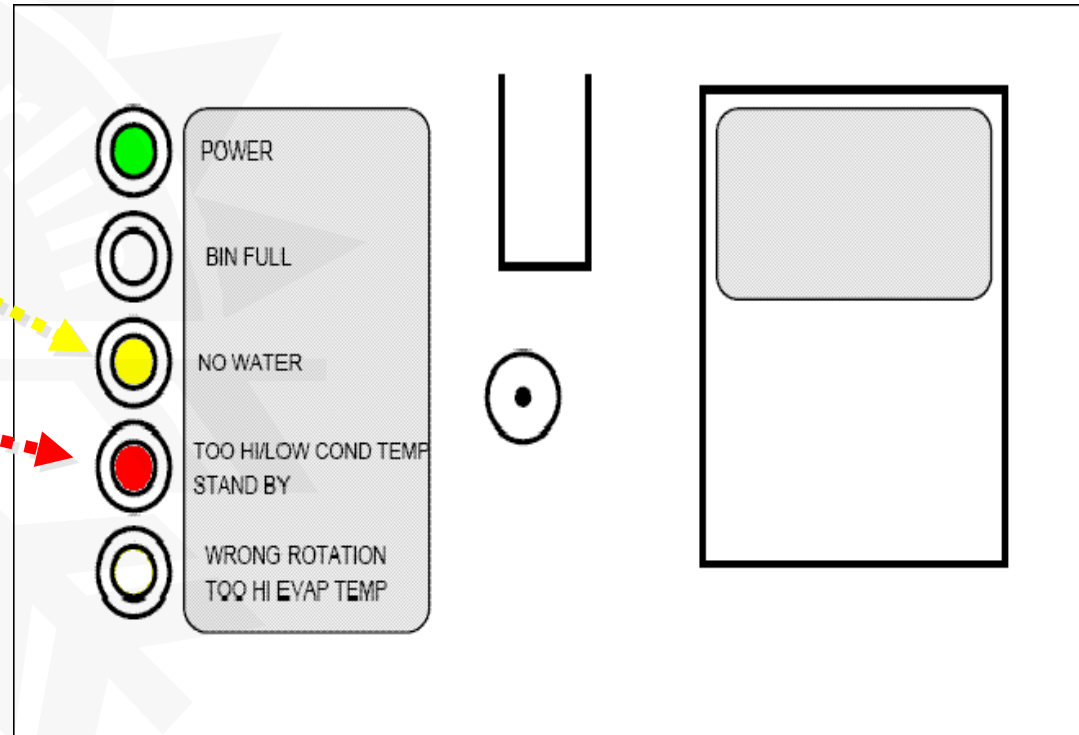
**EVAPORATOR SENSOR OUT
OF ORDER**

No Water YELLOW LED
+

Stand-by Red LED

BOTH BLINKING

**REPLACE EVAPORATOR
SENSOR**

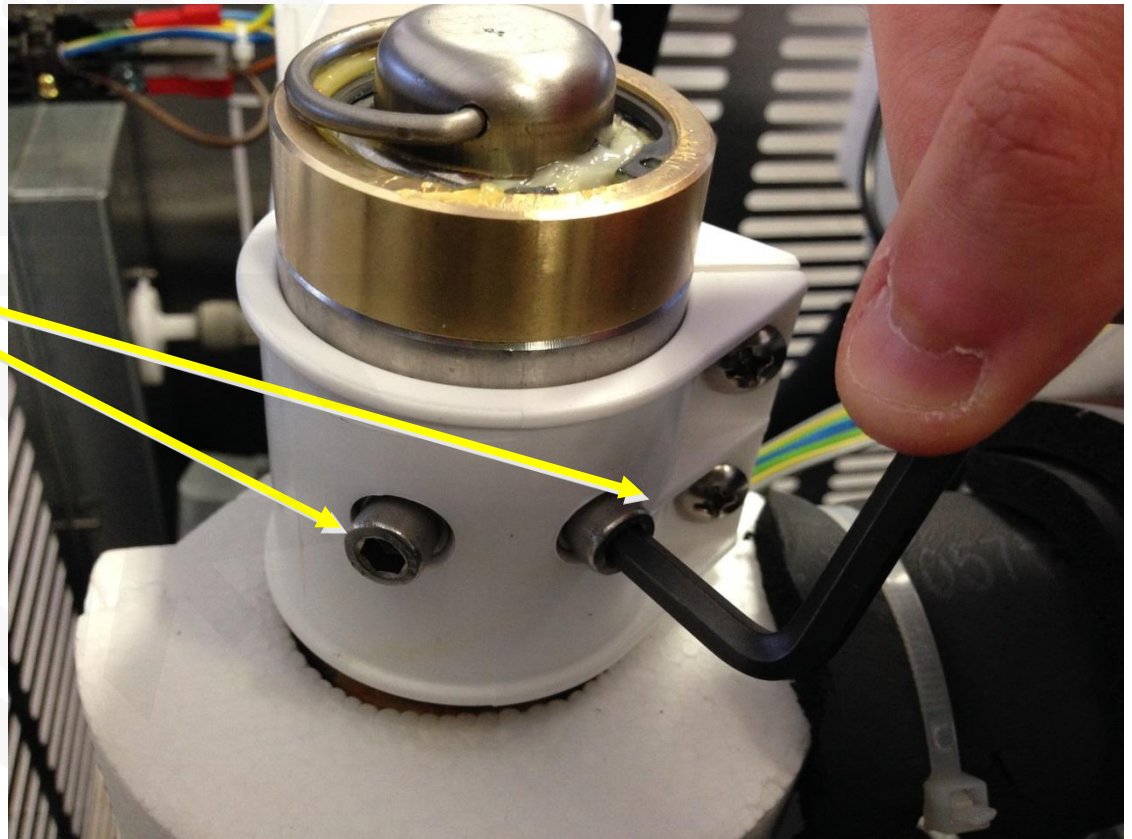
Unscrew and remove the two screws securing the brass ice breaker to the evaporator.

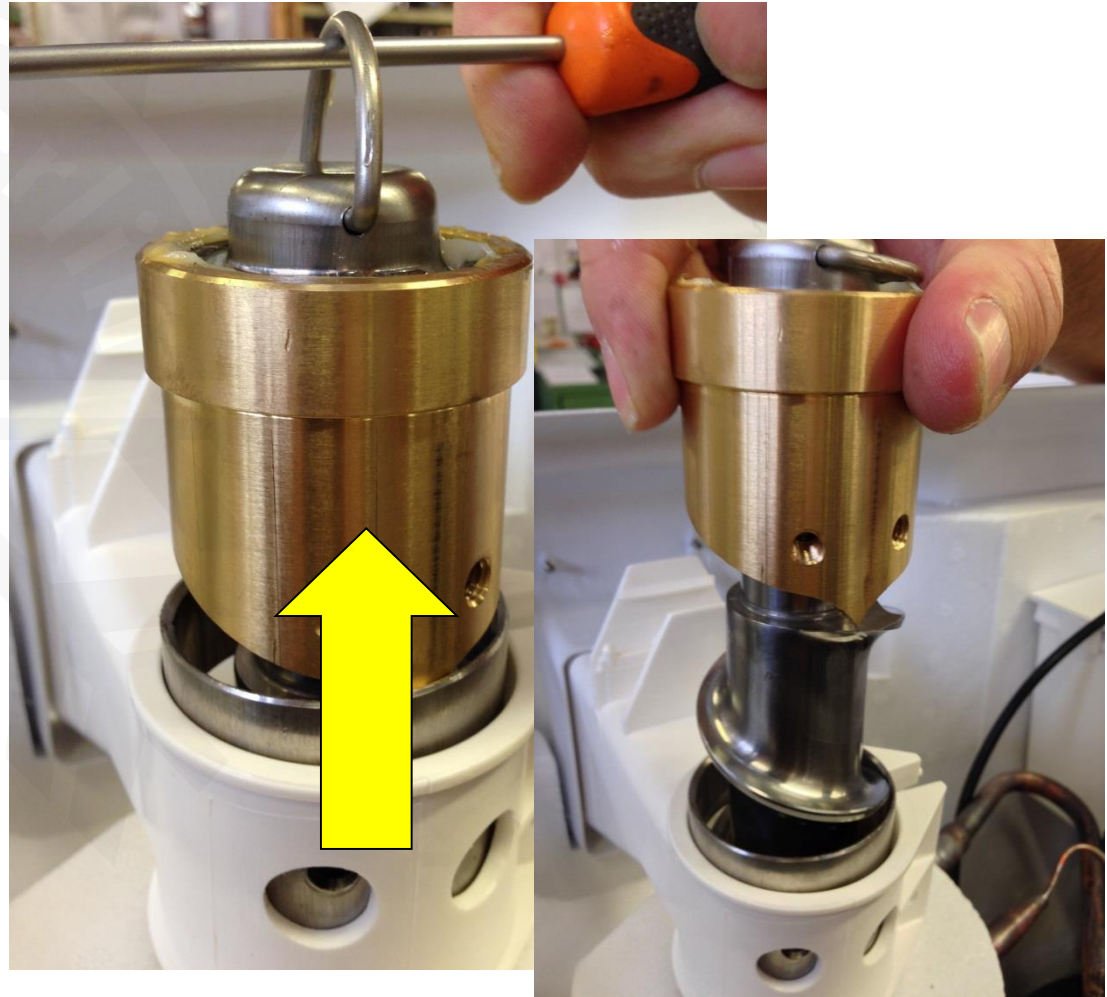
Grasp with a screw driver the wire cap hook located at the top of the freezer and pull out the auger and attached ice breaker assembly.

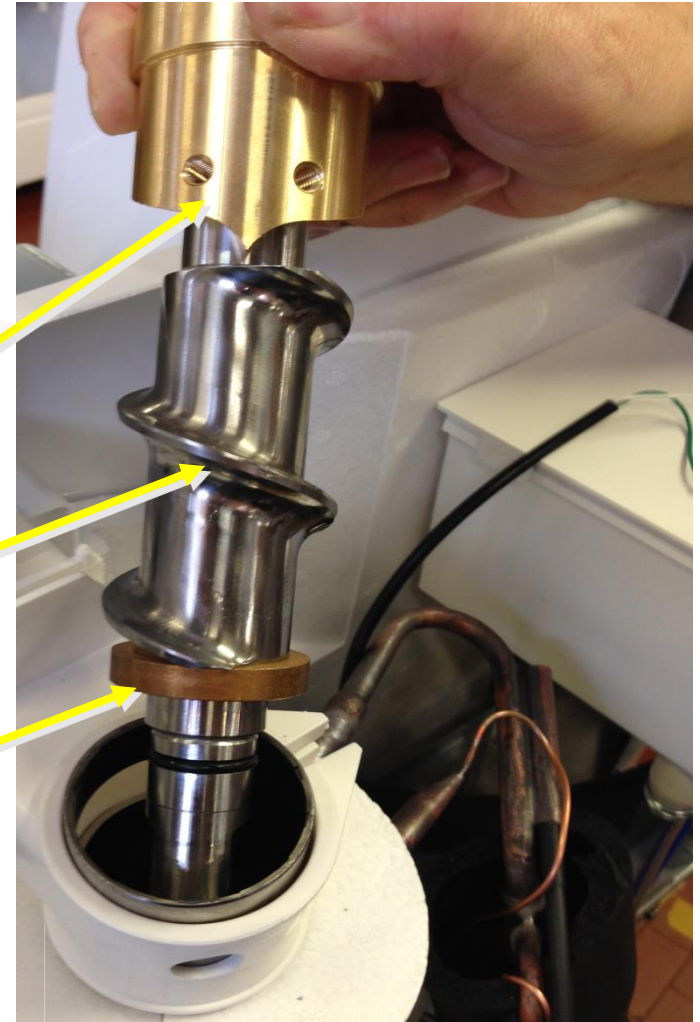
Parts pulled out from the top of the evaporator/worm tube are:

- **Ice breaker assembly**
- **Auger**
- **Top Half of the water seal**

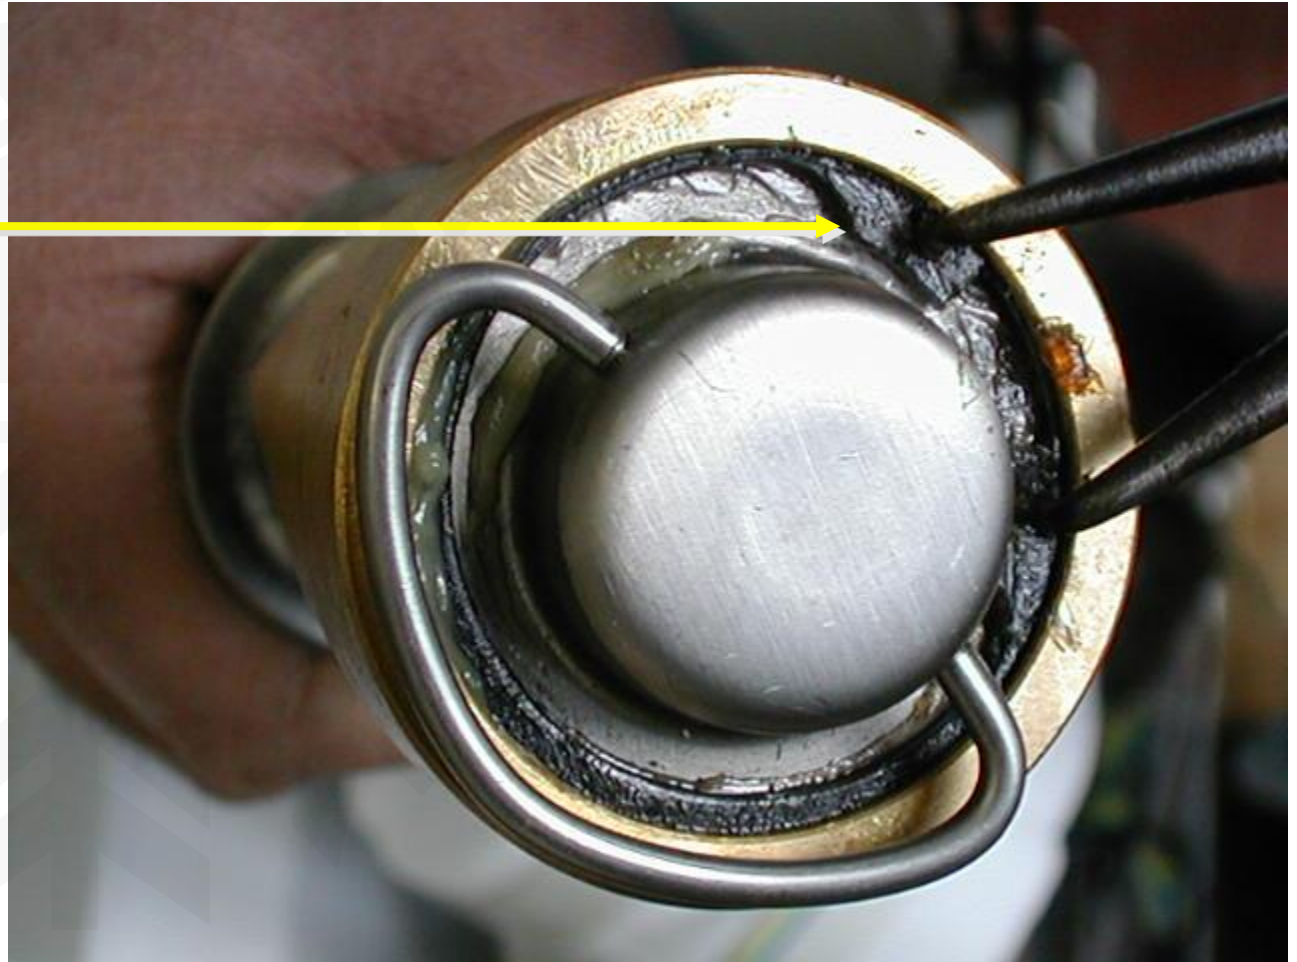
With a clip
ring pliers
remove the
retaining ring
and the cap
from the ice
breaker.

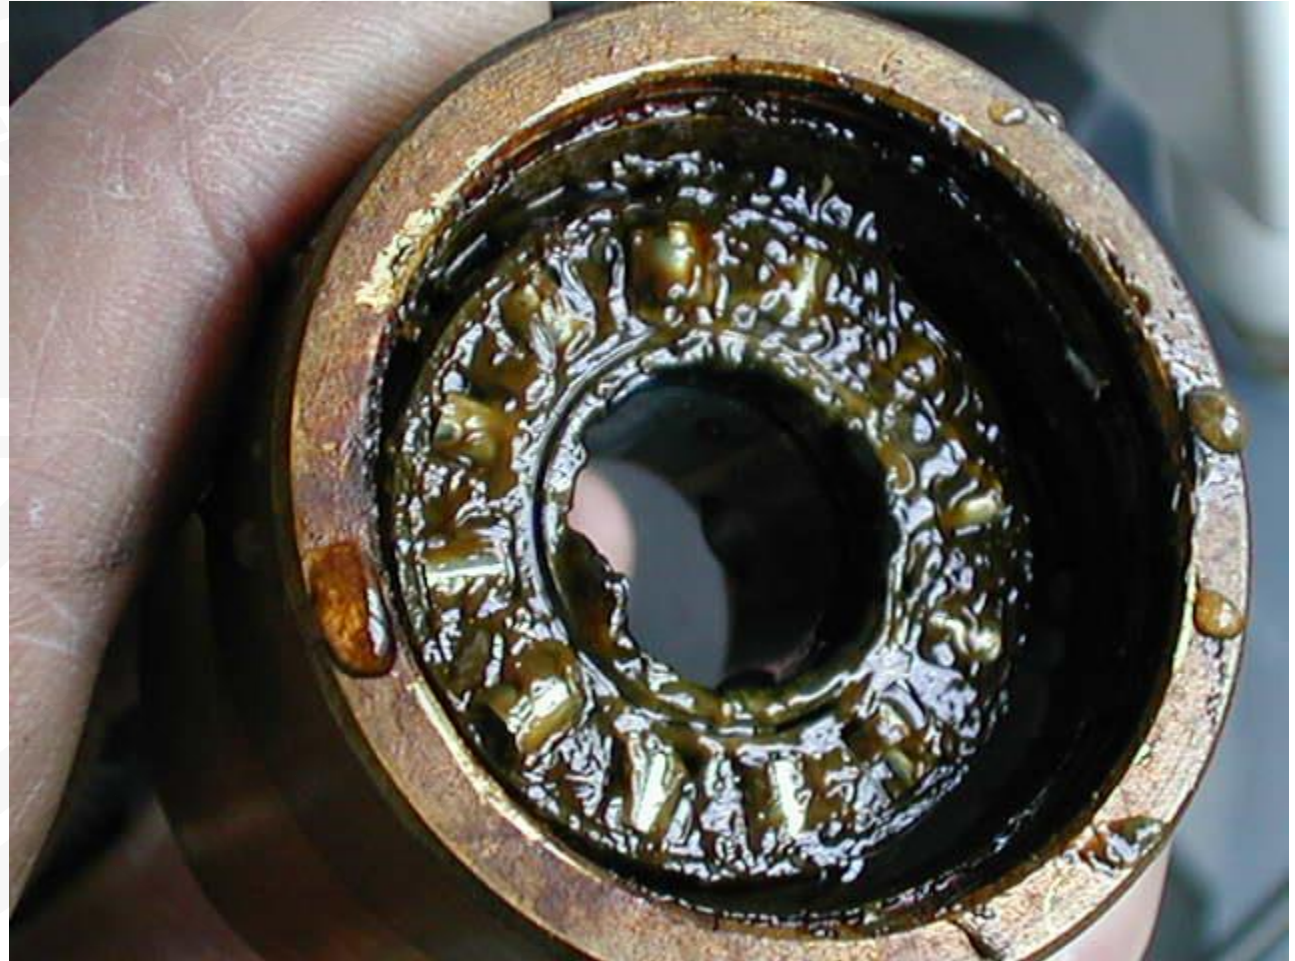
Clean away the old grease from the interior of the ice breaker and inspect the conditions of the top bearing
