SPR – SPN SERIES

SERVICE ANALYSIS

REPLACEMENT OF THE AUGER, WATER SEAL AND BEARINGS

SPR 80-120-200

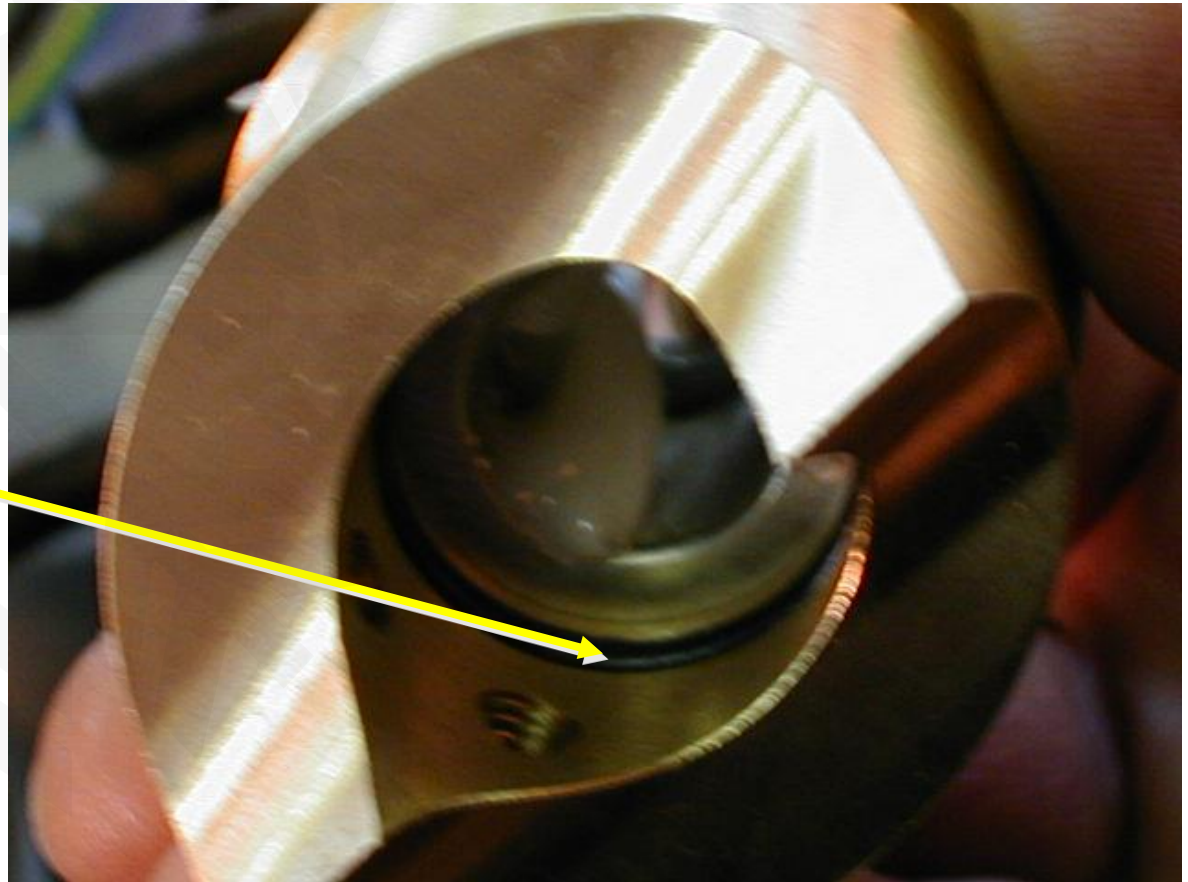
..... as well as
the condition
of the O ring.

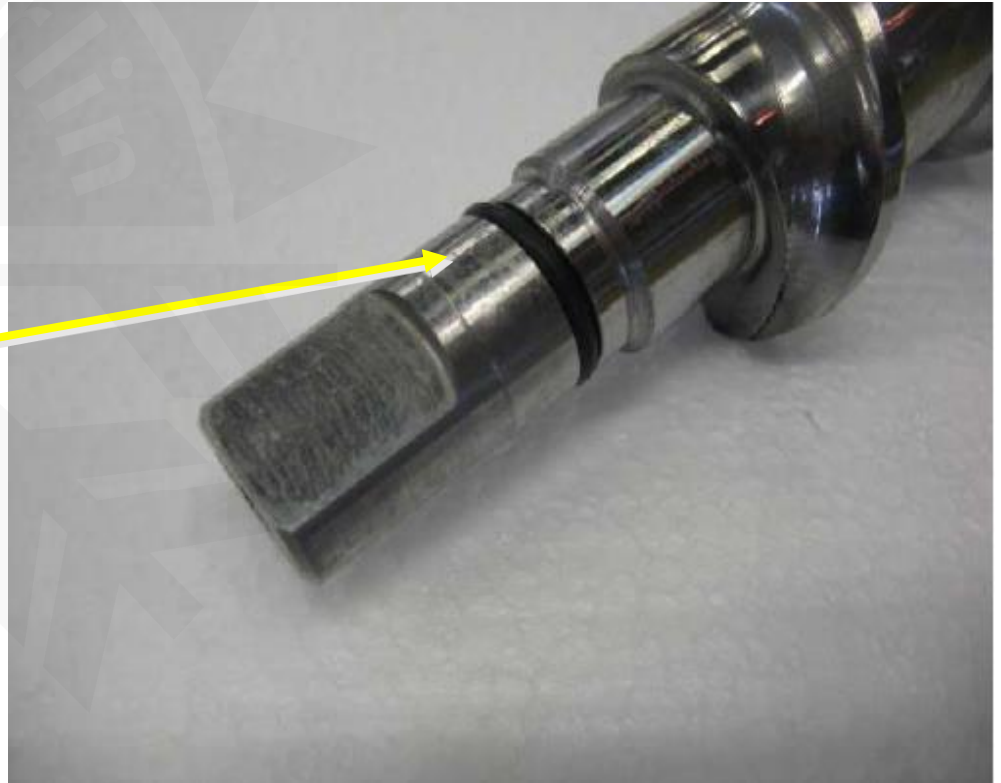
..... And the
condition of
the O ring
located on the
auger shaft .

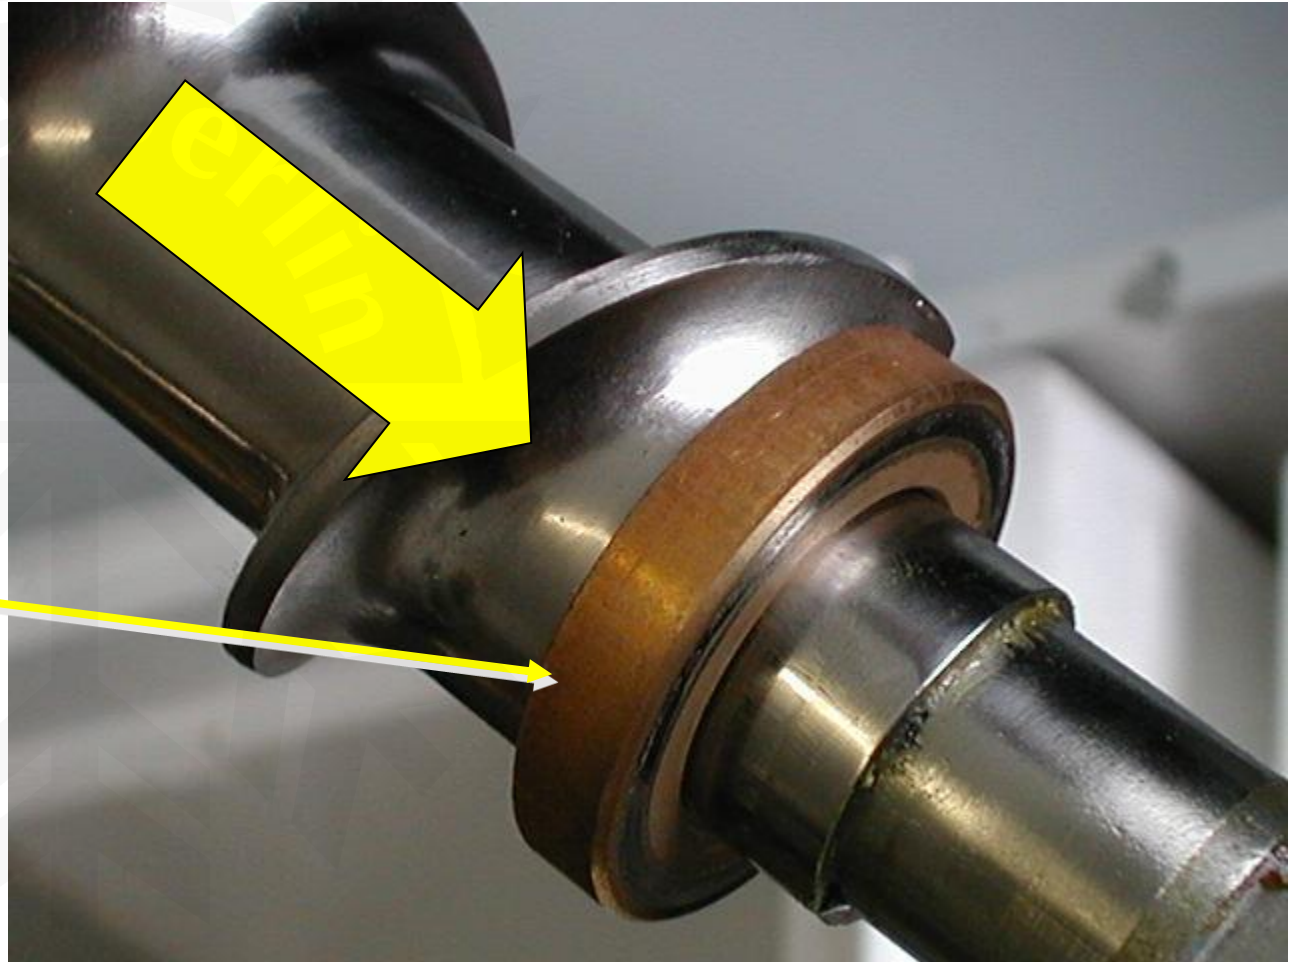
Slide off from
the bottom of
the auger the
upper half of
the water seal.

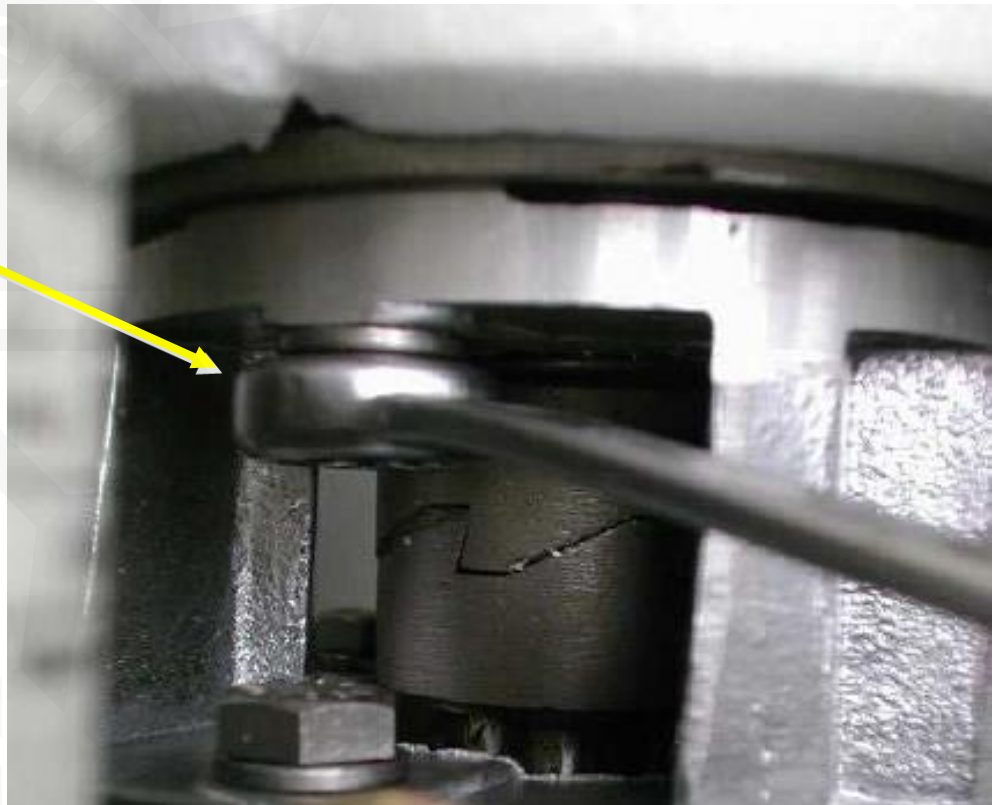
Unloose and remove the three bolts and lock-washers holding the freezer assembly to the aluminum adapter then

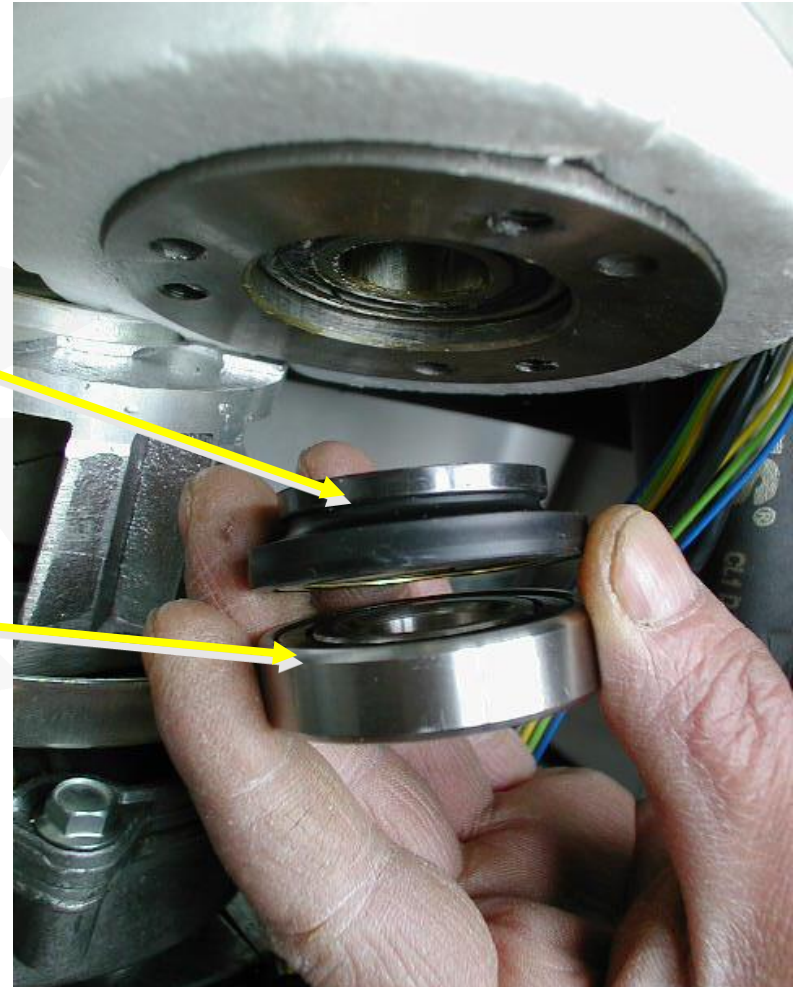
.....tap the lower half
of the water seal

.....and the lower
bearing out the bottom
of the freezer.

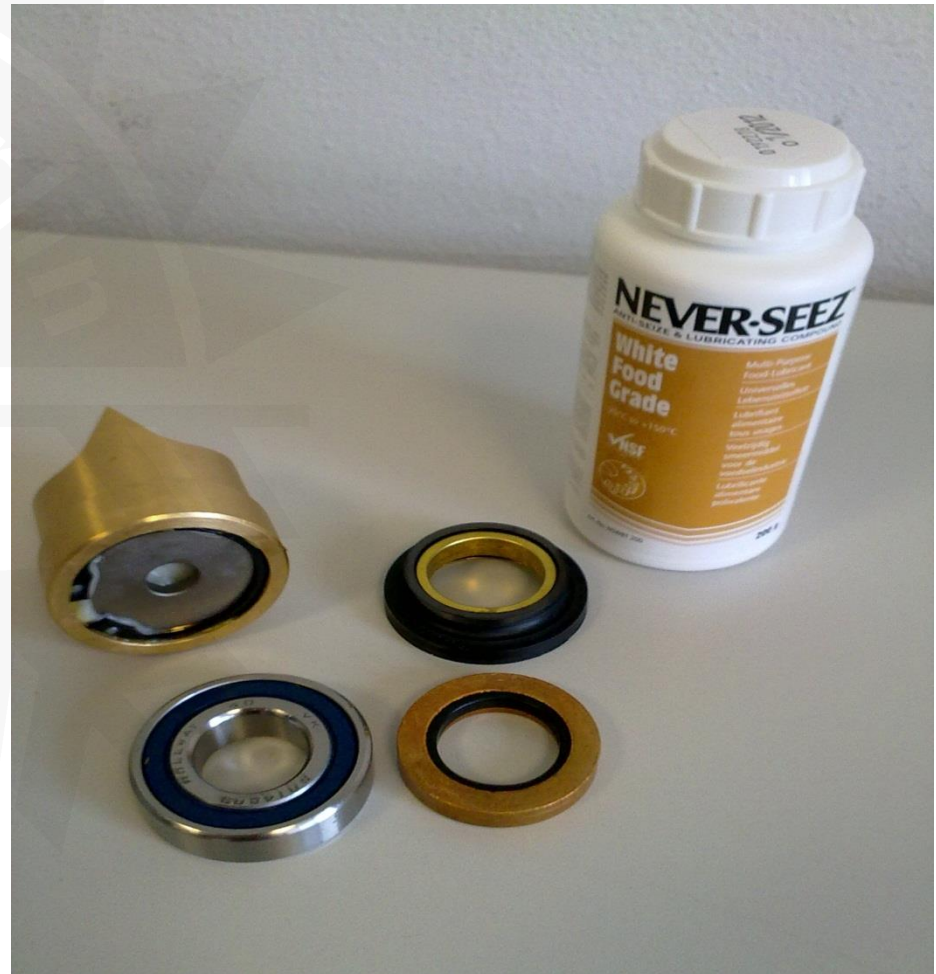
It is good practice to replace the **water seal assembly, the bottom bearing, the ice breaker assy (including top bearing and the O ring)** any time the auger is removed.

A **Kit is available** for this purpose containing a **can of waterproof special grease**.

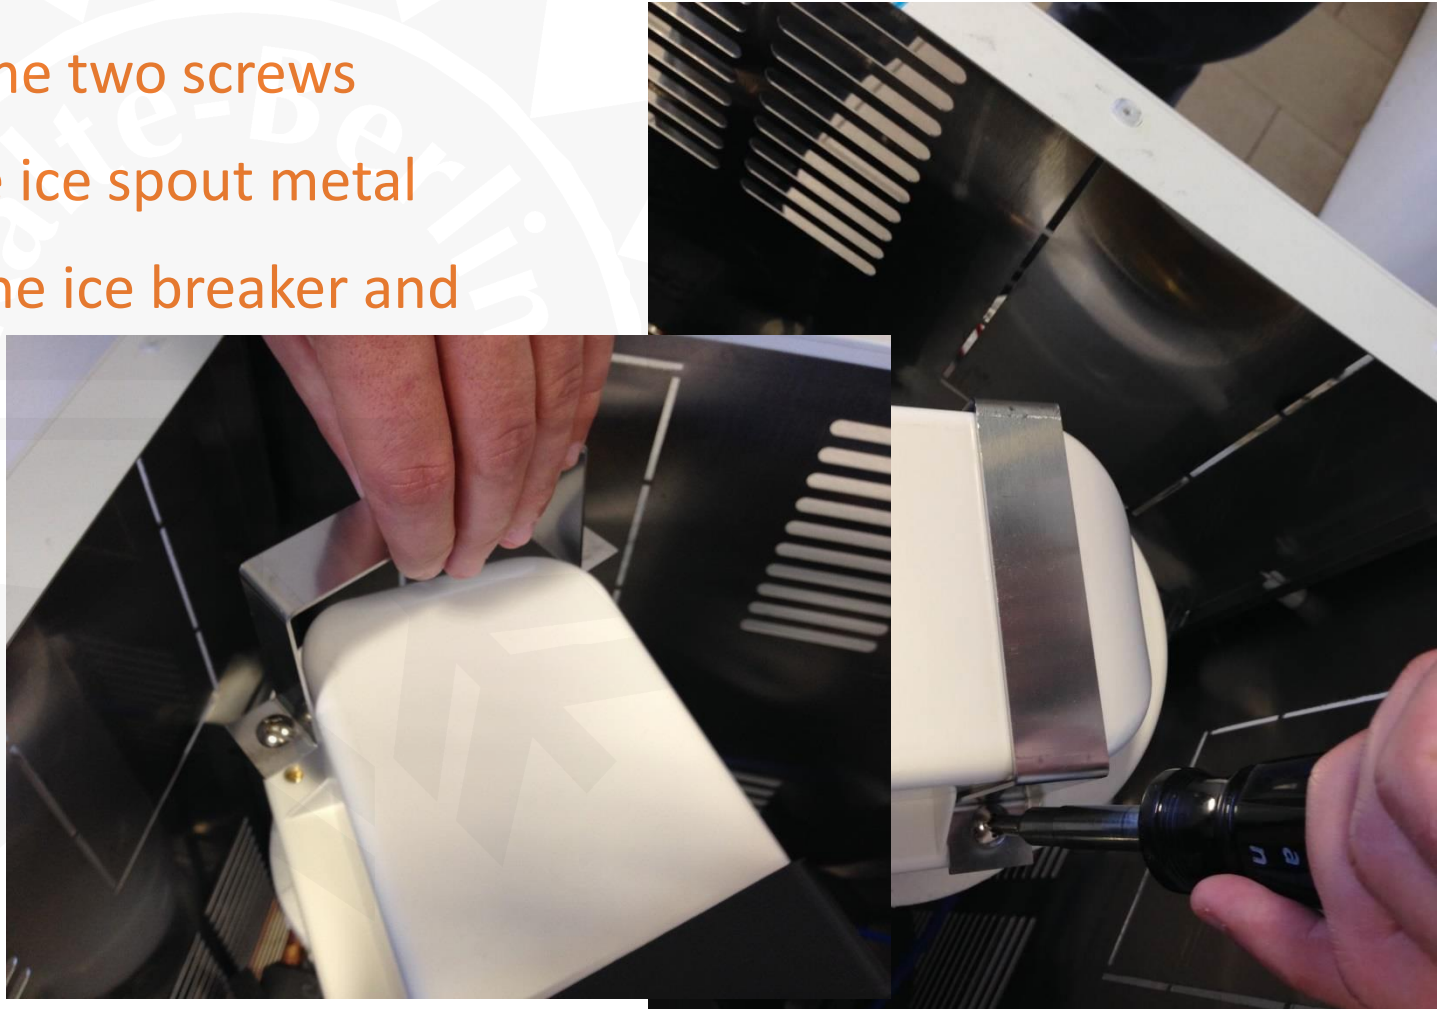
....unloose the two screws
securing the ice spout metal
bracket to the ice breaker and
remove it ...

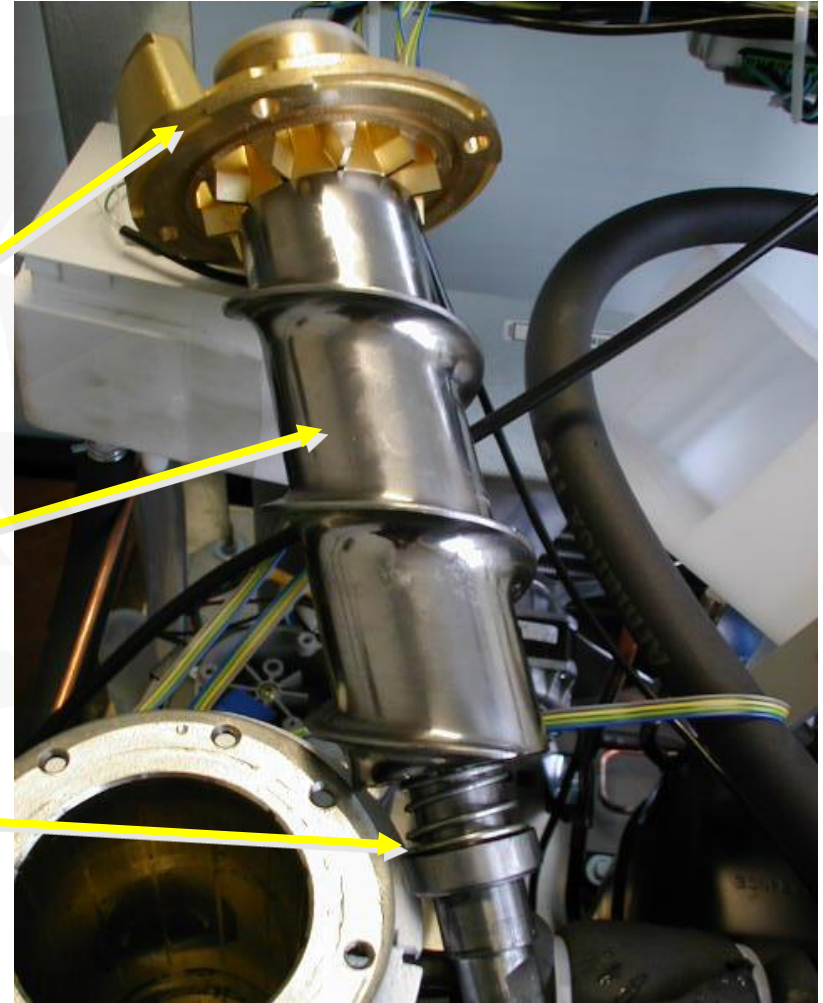
Parts pulled out from the top of the evaporator/worm tube are:

- Ice breaker assembly
- Auger
- Top half of the water seal

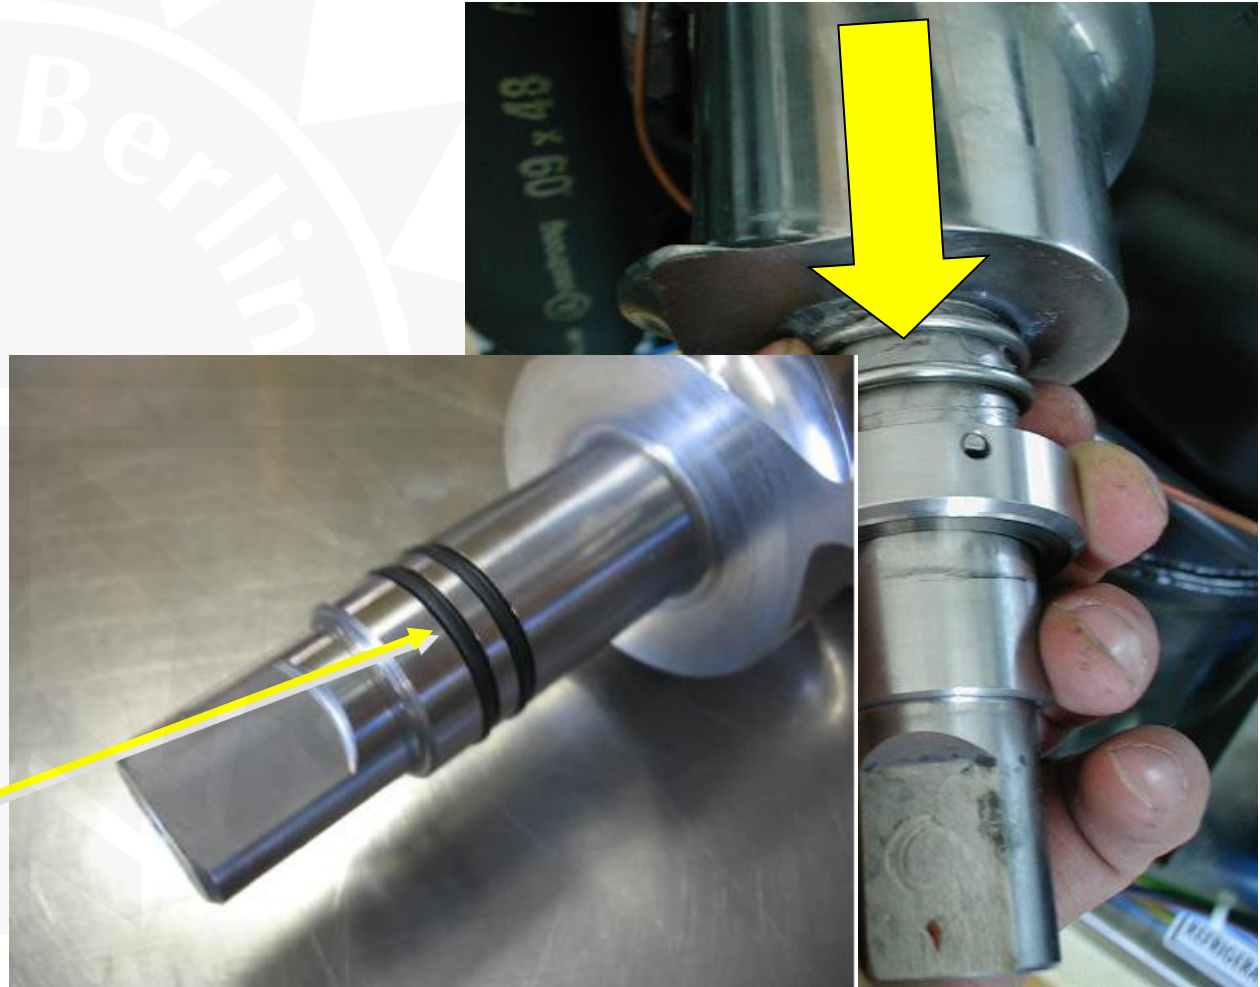
Slide off from the bottom of the auger the upper half of the water seal and check the condition of the two O-rings located on the auger shaft

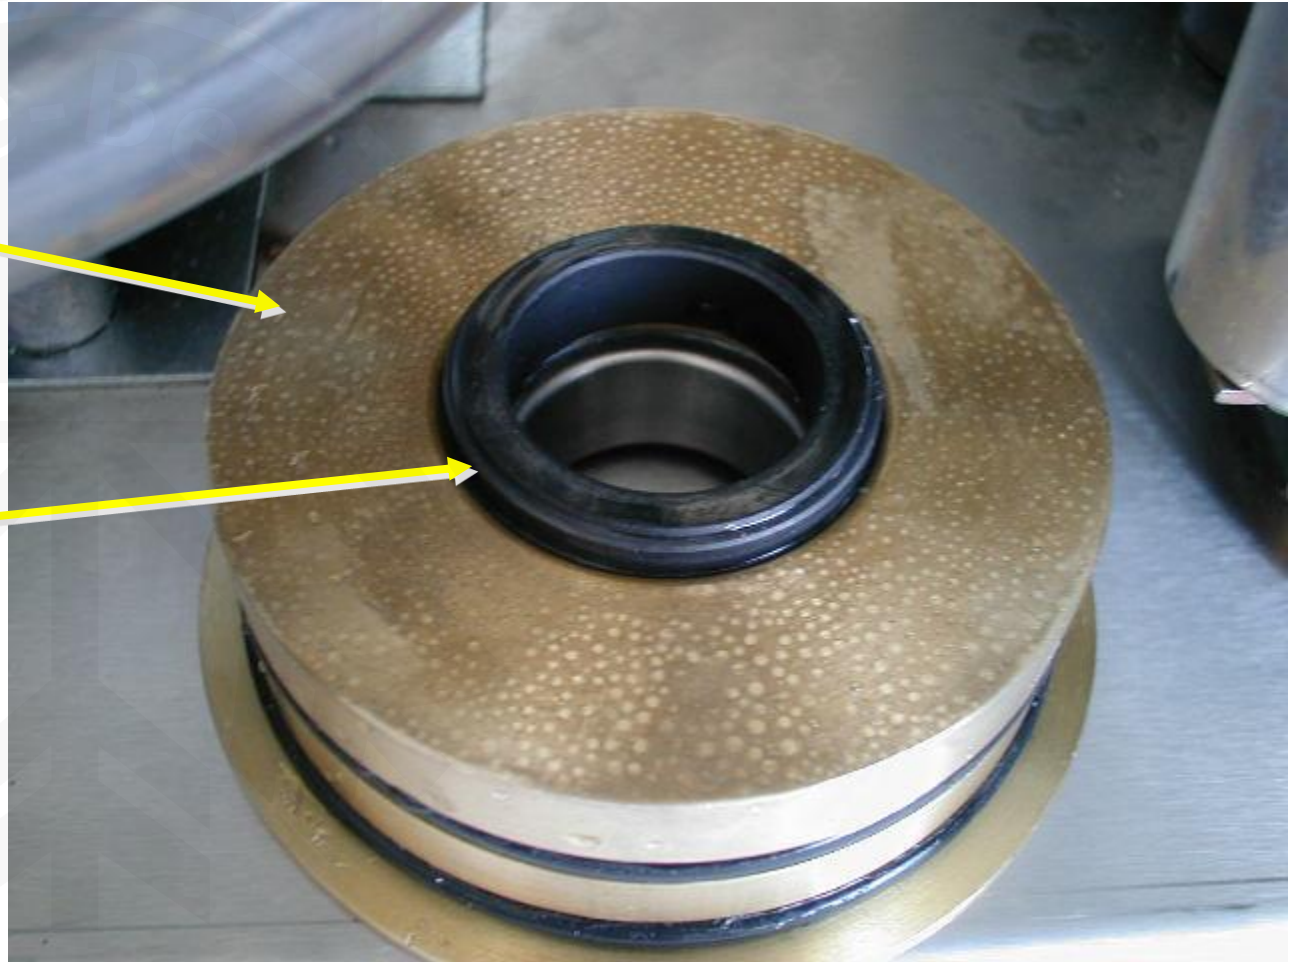
..... the bottom bearing and brass housing assembly with the bottom graphit ring of water seal.

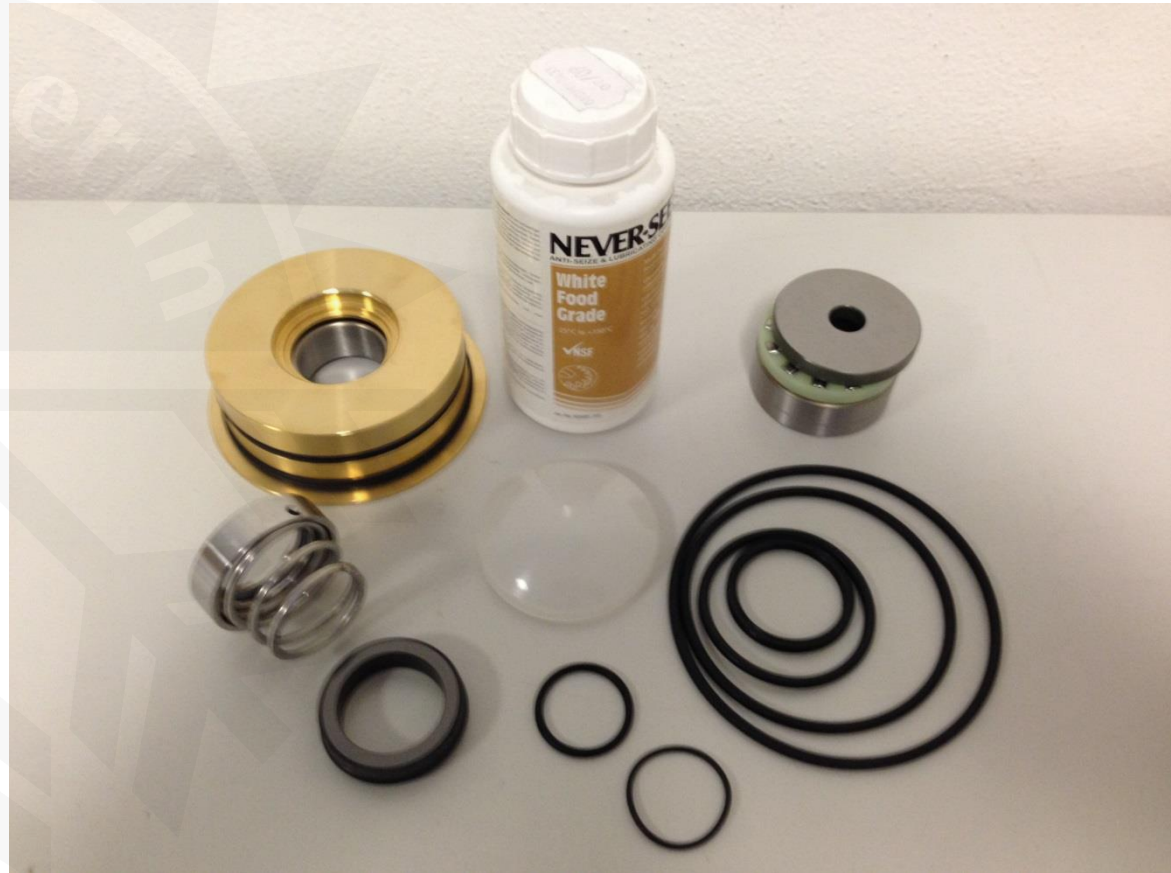
It is good practice to replace the **water seal assembly**, the **two top and bottom bearings** and the **O rings** any time the auger is removed.

A **Kit is available** for this purpose containing a **can of waterproof special grease**.
